Flexural Fatigue Response of Repaired S2-Glass/Vinyl Ester Composites

ARL-TR-4912

August 2009

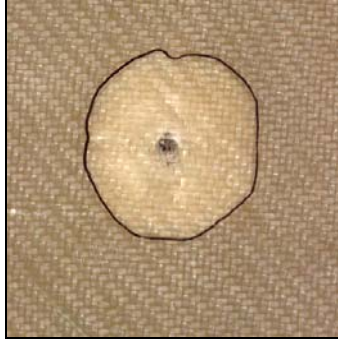
Figure 1. Typical ballistic impact damage of an S2-glass/vinyl ester laminate.

Typical ballistic damage in a woven S2-glass/vinyl ester laminate is shown in figure 1. The projected damage zone is masked by several delaminations through the thickness. Among several possibilities, the repair implementation must (1) be simple to perform, (2) cure at a low temperature to avoid internal pressure buildup, (3) restore the mechanical and ballistic properties of the original composite, and (4) transfer loads from the repair zone to the undamaged material.

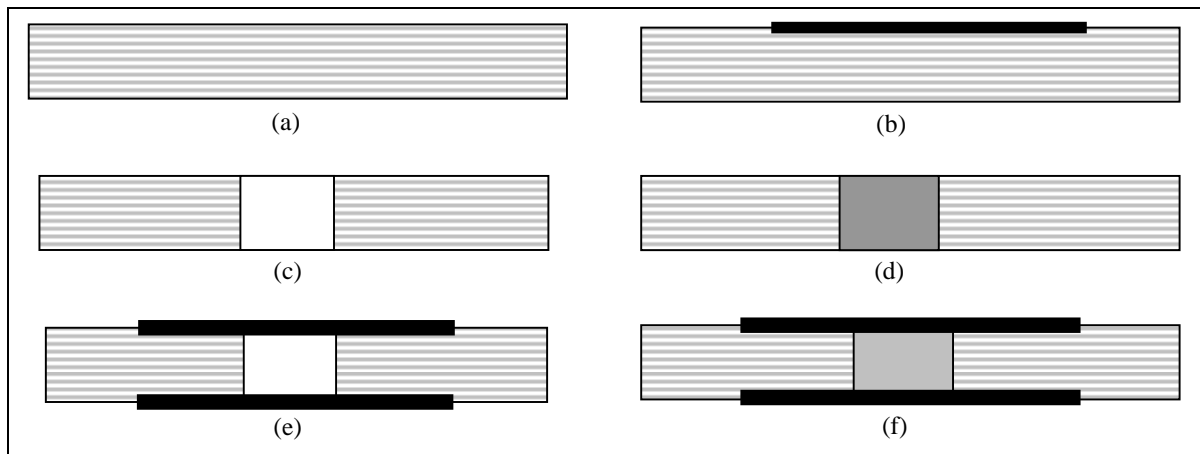
Figure 2. Repair schemes: (a) virgin laminate, (b) virgin laminate with carbon/epoxy ply doubler, (c) laminate with a clean hole, (d) laminate with a microballoon/epoxy-plugged hole or chopped strand mat (CSM)/epoxy-plugged hole, (e) laminate with doubler ply on each side of the clean hole, and (f) laminate with a microballoon/epoxy-plugged hole and doubler ply on each side of the clean hole.

Preliminary work is conducted by considering idealized damage in the form of a clean hole representative of the type of perforation impact. Figure 2 represents various schemes considered in the repair experiments. The laminates considered are (a) virgin, without damage, (b) virgin laminate with a carbon ply doubler (50.8×50.8 mm), (c) ballistically perforated damage, idealized as a clean hole, (d) plugged hole using different plug materials, (e) clean hole with doubler ply on both sides, and (f) plugged hole with doubler ply on both sides. The role of the plug is to maintain stress continuity within the damaged laminate.

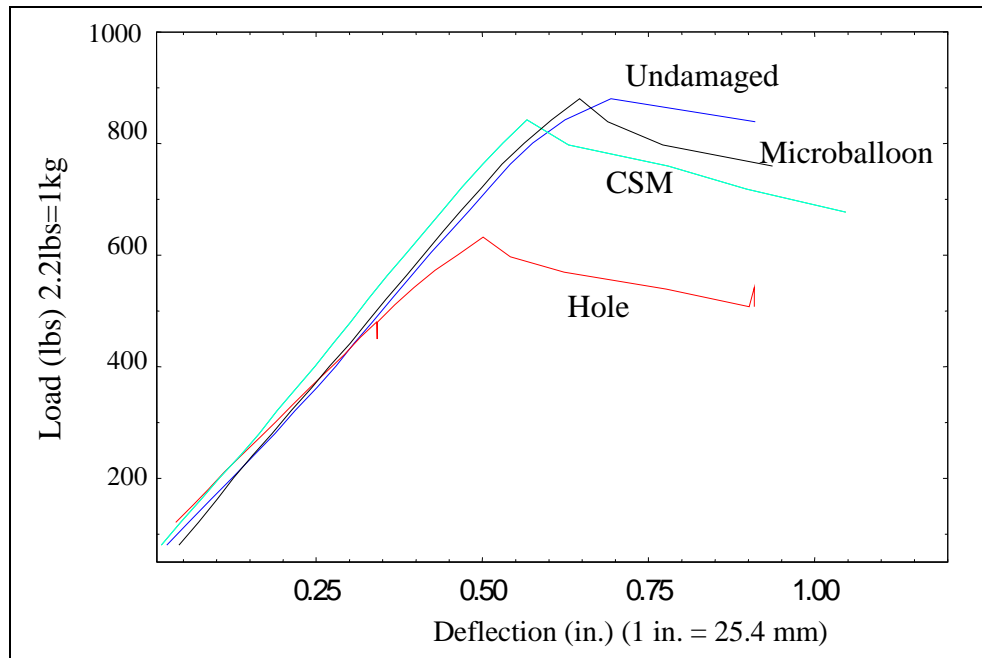
Figure 3. Load-deflection curves from three-point bend tests on 3.81-mm-thick S2-glass/vinyl ester composites (“with” and “without” repair).

The virgin sample was considered the baseline for comparison. For samples with a hole, a strain gauge was bonded to the edge of the hole. Strain was recorded at load steps of 9 kg (20 lb). An MTS 810 load frame with a load-controlled test (crosshead speed of 1.27 mm/min [0.05 in/min]) was used. Figure 3 represents the load-deflection curves from the static flexure experiments, and figure 4 represents the corresponding strain measured from the strain gage. While analyzing the load-deflection profiles, note that both configurations of the repaired samples, i.e., microballoon/epoxy plug and the CSM/epoxy plug, exhibit peak loads comparable to that of the virgin sample. In figure 4, the strain data is represented as load vs. strain traces. The repaired and the virgin samples exhibit comparable strain histories, while the sample with the open hole exhibits a larger strain due to lower stiffness surrounding the hole. The intermittent drops or fluctuation in the strain data can be attributed to the progression of damage in the laminate. Tested samples were cross-sectioned to observe the failure characteristics, if any, of the plug and the doubler ply.

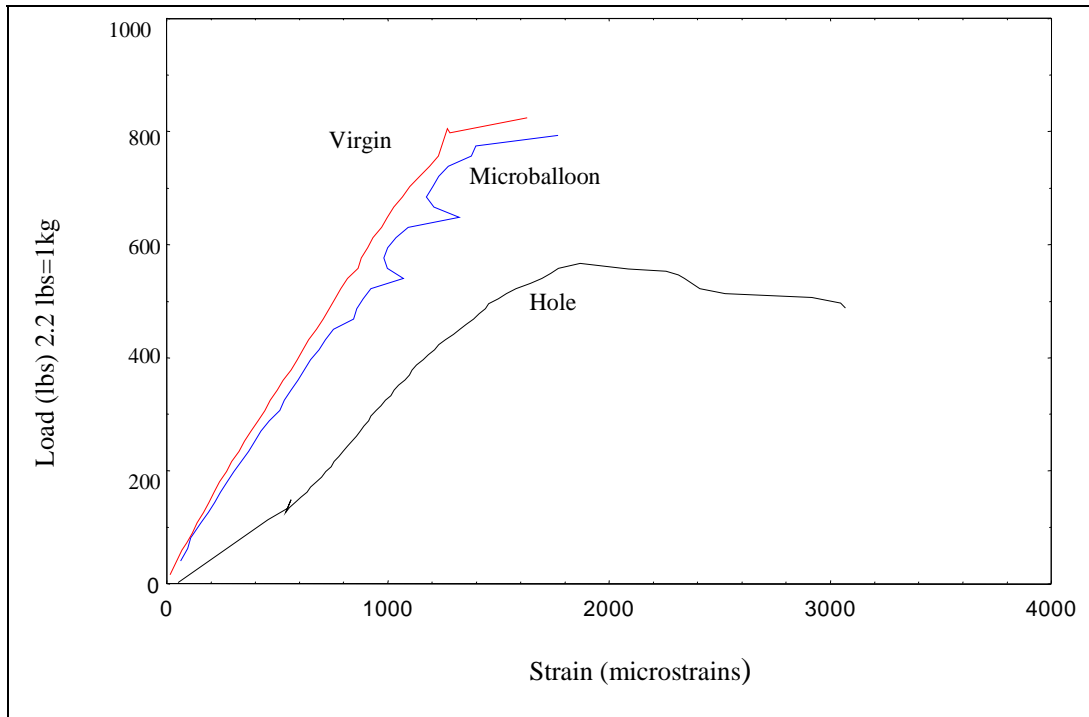
Figure 4. Load-strain (strain gage measured) curves from three-point bend tests on 3.81-mm-thick S2-glass/vinyl ester composites (“with” and “without” repair).

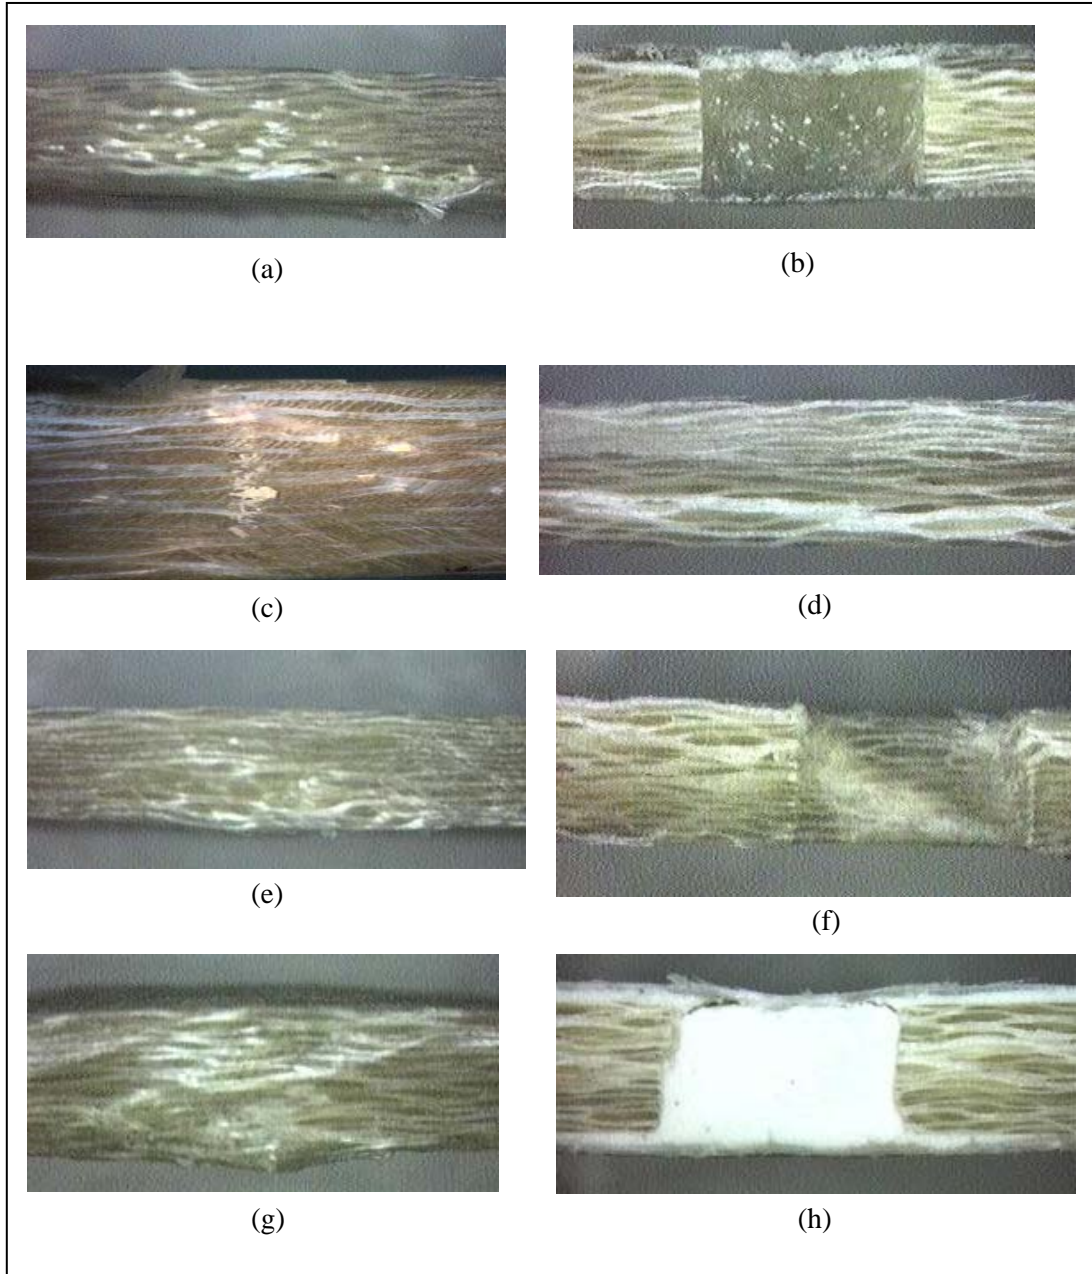
Figure 5. Microstructure of S2-glass/vinyl ester samples after three-point bend tests. The left-hand column is the edge of the sample before sectioning, and the right-hand column is the sectioned view. Views: (a and b) CSM/epoxy plug, (c and d) virgin/undamaged, (e and f) clean hole, and (g and h) microballoon/epoxy plug.

The cross section was taken along the width of the sample. The microstructure is shown in figure 5. The left-hand column of figure 5 shows the samples as observed from the edge prior to sectioning. The right-hand column represents the sectioned views. In all samples tested, the dominant failure occurs at the compression zone. This is in contrast to studies on aerospace-relevant thin-section composites (7–10) where dominant flexural failure is on the tensile side. The typical failure of the virgin sample indicates matrix whitening on the compression side and through-the-thickness microdelaminations in the compression zone. The cross section with a clean hole indicates damage developing at the edges of the hole in the compression zone, hence weakening (shear deformation) the matrix. The samples repaired using CSM/epoxy and microballoon/epoxy plugs show no indication of interfacial failure at the plug-to-composite interface or within the body of the repair plug. Instead, damage occurs through matrix yielding surrounding the areas of the repair, much like the virgin samples. Some indications of damage at the plug-to-doubler ply interfaces were observed in both the repair cases.

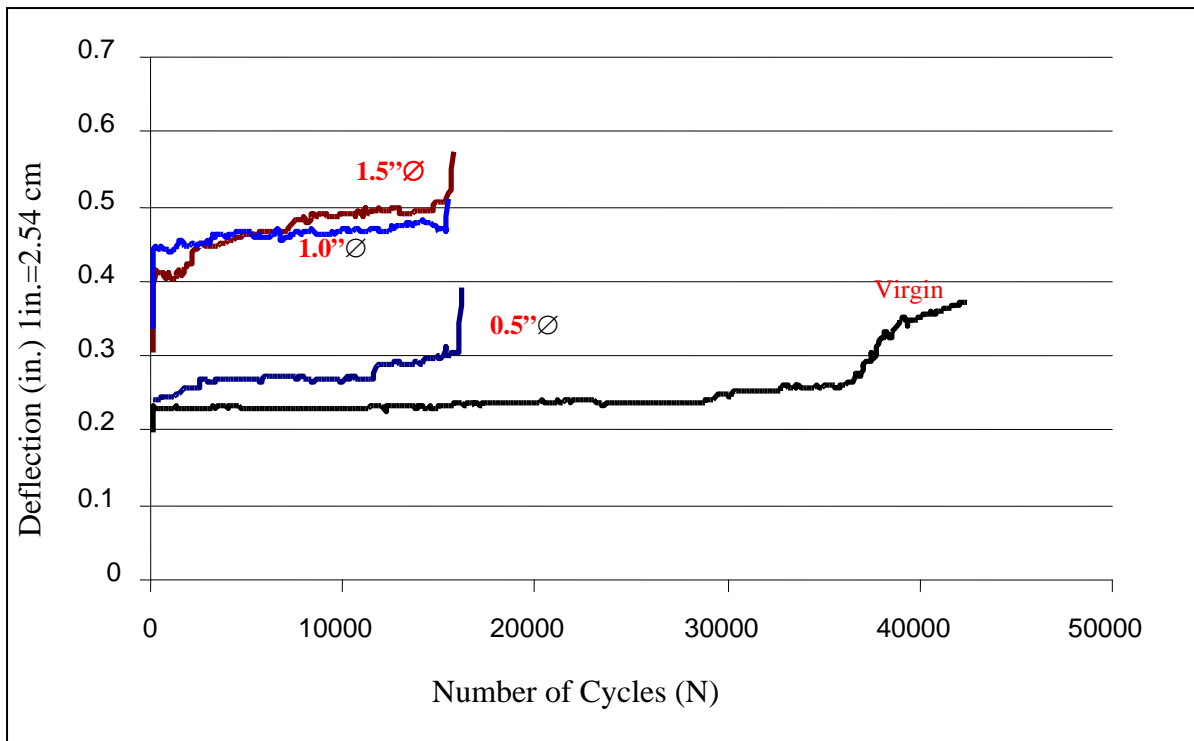
Figure 8. Effect of hole: deflection vs. number of cycles.

Figure 8 represents the fatigue response for the samples with holes of different diameters as a function of number of cycles to failure. As seen from the figure, the virgin sample tends to deflect less due to being stiffer, and its fatigue life is about 135% more, compared to the sample with a 0.5-in-diameter hole. The hole results in reduced stiffness. The damage is in the form of initiation of microdelaminations on the compression side (much like those observed in the static tests) which propagates with the increasing number of fatigue cycles. The cracks originated from the hole on the top surface with certain orientation (15°) to the breadthwise axis of the sample. In the case of the 38.1-mm (1.5-in)-diameter hole (the worst case scenario), the initial cracks were seen as early as the 600th cycle and, subsequently, more cracks appeared at regular intervals, which are evident by the fluctuation in the amount of deflection. A similar damage-progression trend was followed by all the notched samples. In the case of the virgin samples, the initial crack was seen after 36,000 cycles, following a steady increase in the deflection level. The cracks in the virgin sample originated between one of the loading arms and the support. The damage was predominantly caused by shearing around the support locations and by delamination. For at least three virgin samples tested, the onset of failure occurred around the supports. For the samples with the hole, the damage was primarily caused by compression failure surrounding the hole.

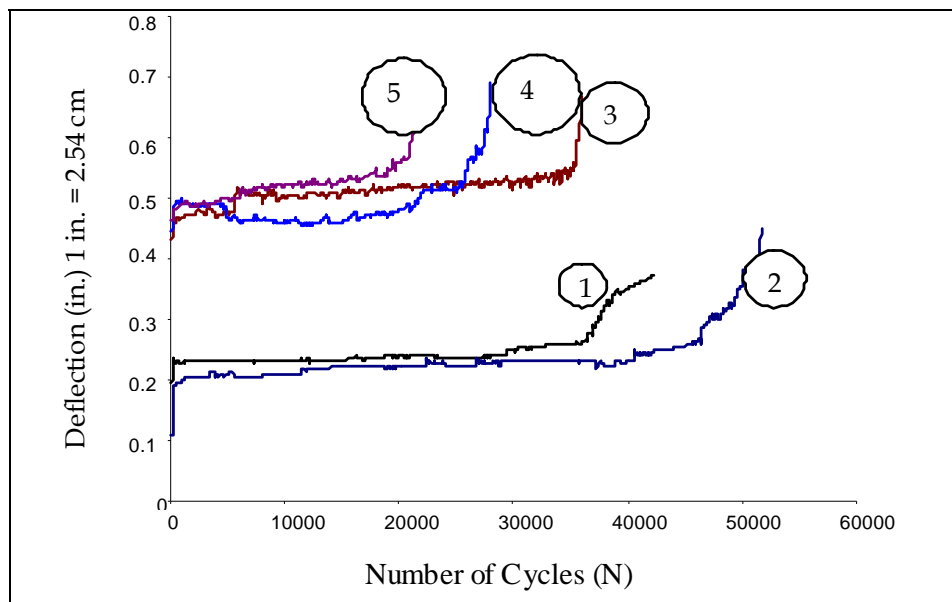
Figure 9. Fatigue tests—effect of carbon/epoxy doubler (unfilled hole): (1) virgin, (2) virgin with doubler ply, (3) 12.7-mm hole with doubler, (4) 25.4-mm hole with doubler, and (5) 38.1-mm hole with doubler.

Figure 9 represents the fatigue response of the samples with an unfilled hole with a single ply of carbon/epoxy doubler. This case was considered to investigate the role of the doubler in the fatigue response. The results are also compared to the virgin panel and a virgin panel bonded to a similar doubler. Table 2 summarizes the fatigue results for this category. The doubler plies (without plugging the hole) increased the fatigue life over non-doubler test results by 100% for a 12.7-mm hole, 57.2% for a 25.4-mm hole, and 21.91% for a 38.1-mm hole. The double ply is an effective stress transfer design. The failure in terms of matrix whitening and microdelamination originates within the edges of the hole and propagates across the width of the sample.

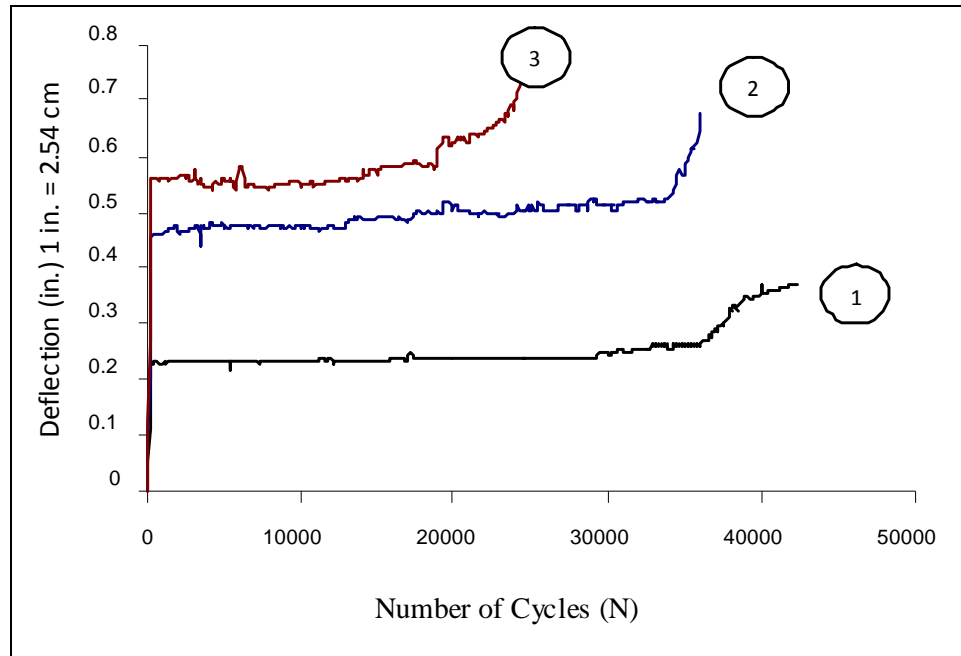
Figure 10. Fatigue tests—microballoon/epoxy plugs: (1) virgin, (2) 12.7-mm hole, and (3) 25.4-mm hole. Data for 38.1-mm hole was not available.

In this case, the samples were plugged with the microballoon/epoxy mixture, without the use of the doubler ply. This was done to ascertain the fatigue life in the absence of the doubler. Figure 10 represents the fatigue response of the samples. Table 3 summarizes the results from the tests. Plugging the hole with only the microballoon/epoxy increases the fatigue life, as compared to the samples with the clean hole. For the sample with the 12.7-mm (0.5-in-diameter) hole, the fatigue life increase is 100.05%. For the 25.4-mm (1-in) hole sample, the increase is 37.07%, as compared to the respective clean hole samples. These tests demonstrated that the use of a doubler was more effective in distributing the compressive stresses as the hole diameter increases. For the 12.7-mm hole, either repair treatment yielded a comparable number of cycles to failure, ~36,000. Failure was across the sample width originating from the hole.

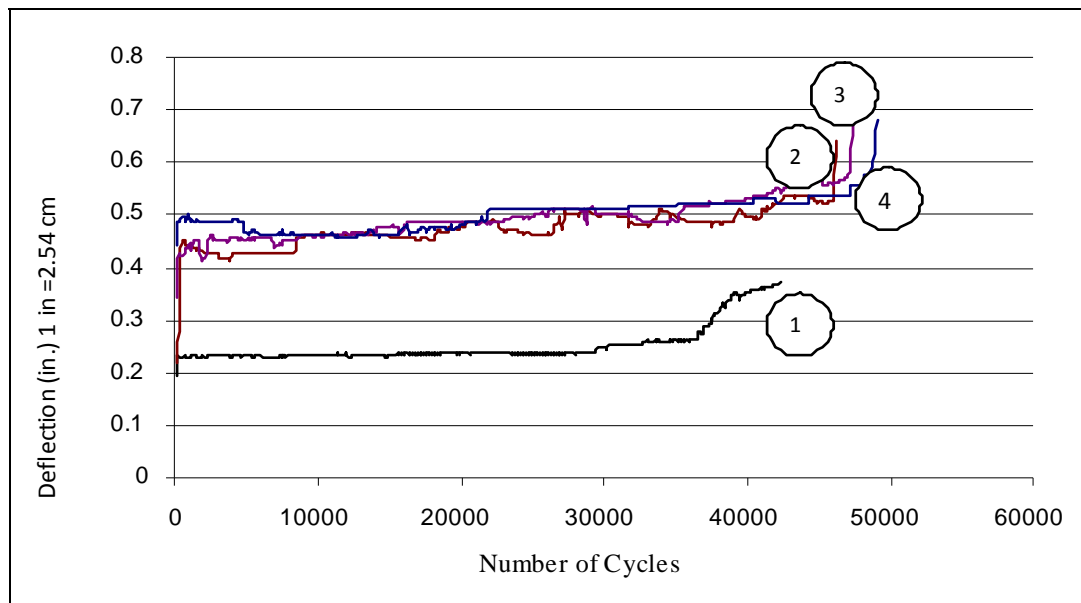
Figure 11. Fatigue tests—carbon/epoxy doubler + microballoon/epoxy plug: (1) virgin, (2) 12.7-mm hole, (3) 25.4-mm hole, and (4) 38.1-mm hole.

Based on the results of doubler and microballoon fatigue tests (i.e., the microballoon/epoxy and the carbon/epoxy ply doubler), the test matrix was extended to include a combined repair test for the microballoon/epoxy plug and the doubler. Figure 11 compares the fatigue response of the samples. Table 4 summarizes the test results. There was a 158% increase in the fatigue life for the repaired samples with the 12.7-mm hole, 153.9% for the 25.4-mm hole, and 163.25% for the 38.1-mm hole, in comparison to the clean hole samples. The initial crack propagation started well after 6000 cycles, and the cracks were seen to stabilize after initial flexing. These tests demonstrate that the role of both constituents is effective in enhancing the repair. The microballoon/epoxy plug provides the stress continuity, while the doubler supports the compression side stresses. In all these tests, the role of the tensile side doubler was minimal, as it snapped open within a few hundred cycles, while the compression side doubler remains well bonded through failure. Failure in these samples originated through a microcrack formation around the repair area and progressed across the width of the specimen at the repair location.
